Accelerated rain erosion of wind turbine blade coatings

Ph.D. Thesis

Ph.D. Thesis
by
Shizhong Zhang

CHEC Research Center
Department of Chemical and Biochemical Engineering
Technical University of Denmark, DTU, Denmark
August 2014

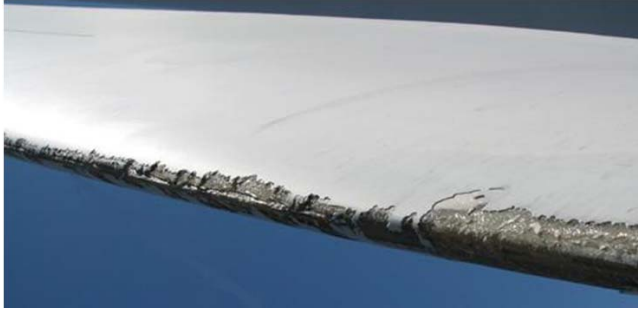
Figure 1.7 Leading edge erosion of a wind turbine blade. Reproduced from [21].

Depending on operating conditions, erosion of rotor blade leading edges (Figure 1.7) can affect wind turbine energy generation efficiency.

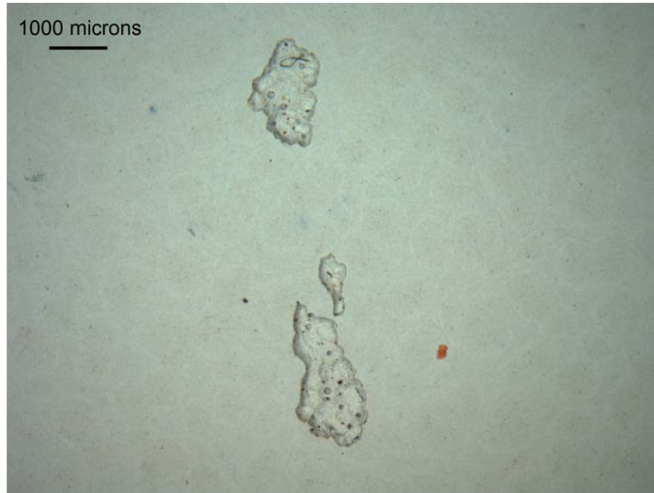
Figure 3.6 Optical microscopy of water jet erosion failure of Coating A applied on flat steel panels and using a water nozzle-coating distance of only 5 cm (Experiment 4).
